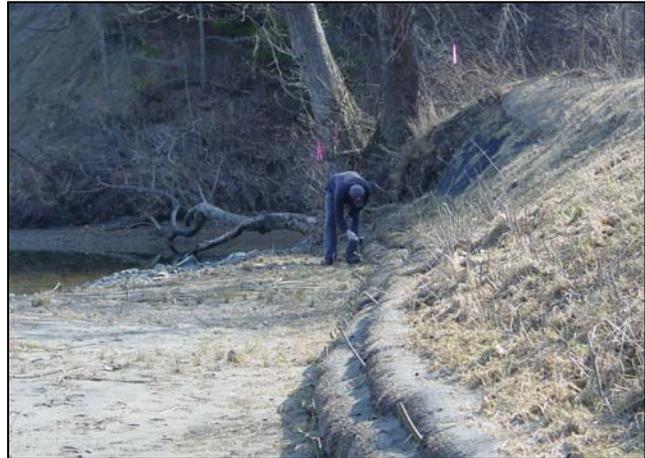
**Photo 1:**

Installing willow stakes at Durkee Point in March. Willows were installed in front and in between the coir fascines.

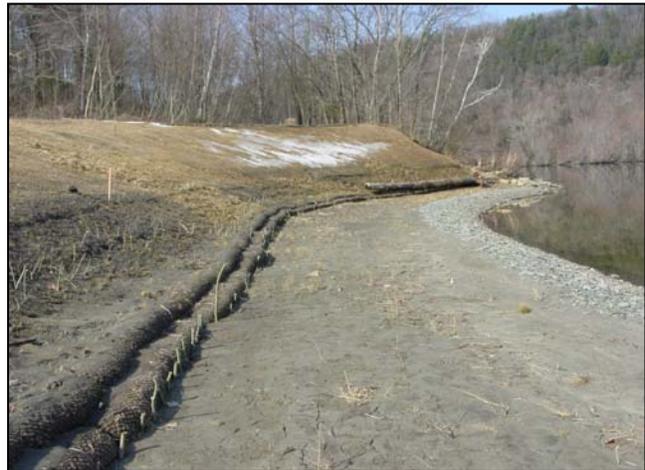
**Photo 2:**

Durkee Point after the willow stake installation.

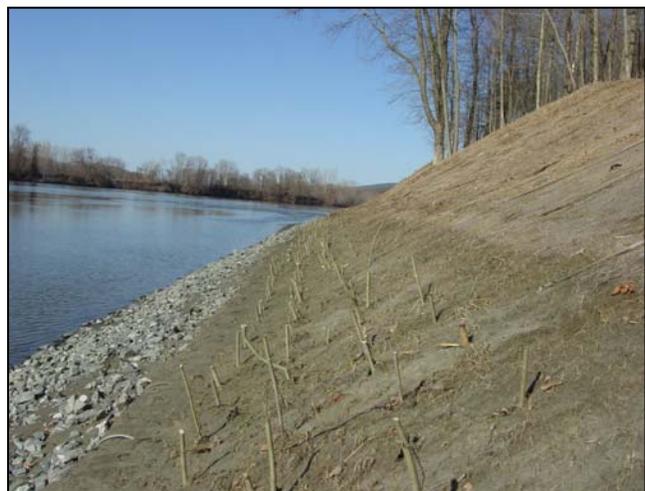
**Photo 3:**

River Road following the installation of additional willow stakes. All willow materials were taken from the Bennett Meadow cutting block.

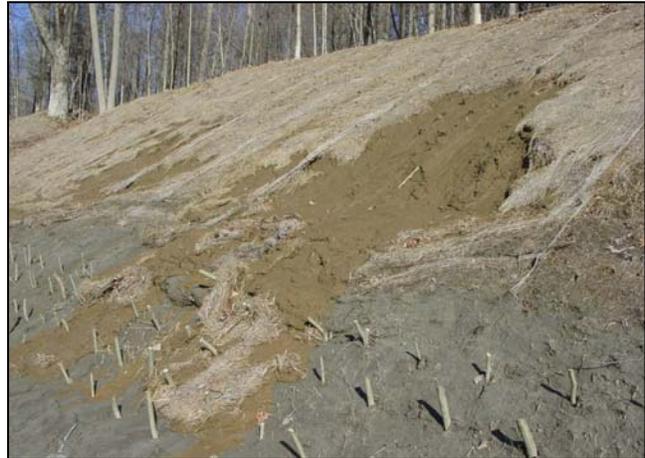
**Photo 4:**

Spring melting caused minor mudslides and ripping of erosion control blanket. All disturbed soils were stabilized with seed and stronger erosion control fabric.

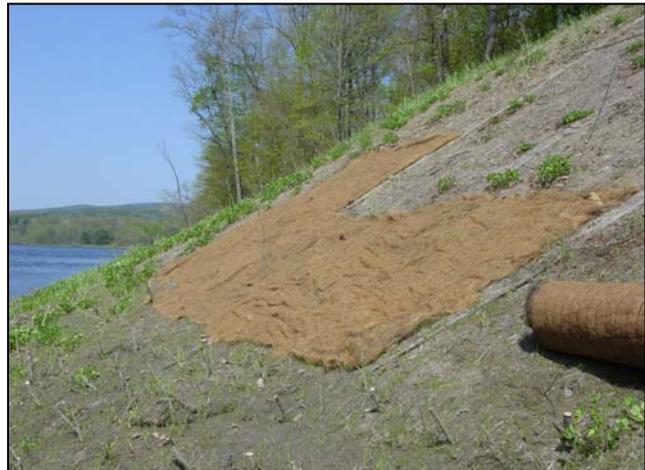
**Photo 5:**

Eroded areas were seeded and covered with C2 erosion control fabric. This fabric has more strength for better support of difficult areas subject to erosion.

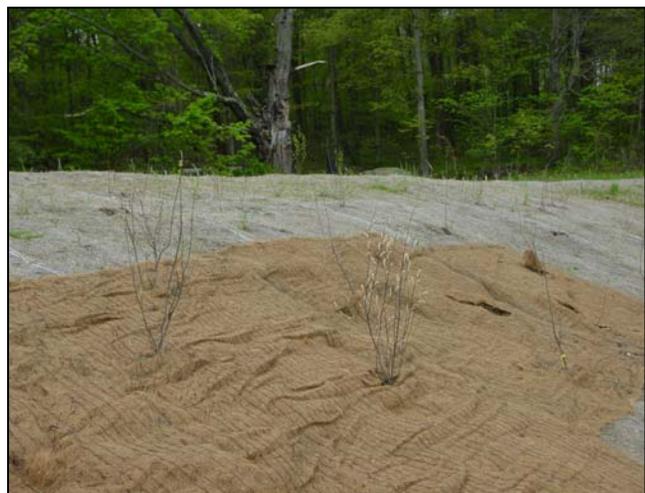
**Photo 6:**

Bare root shrubs were installed along the river banks.

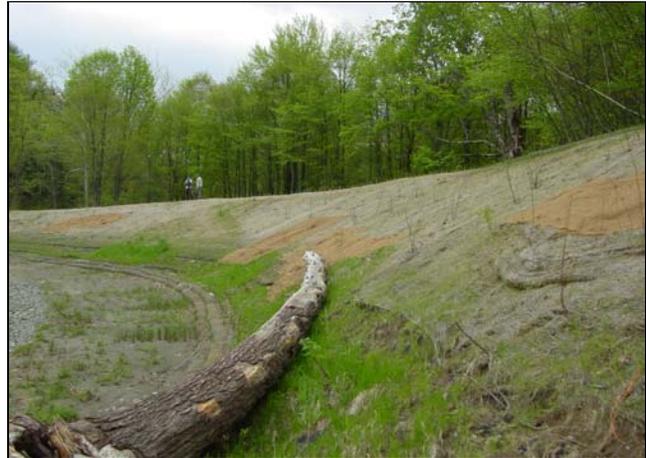
**Photo 7:**

Durkee Point following the installation of the bare root plant materials along the river bank.

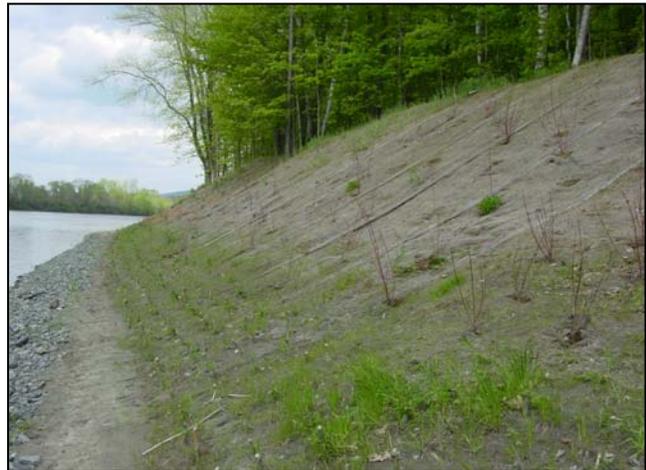
**Photo 8:**

River Road after the bare root plants were installed along the river bank.

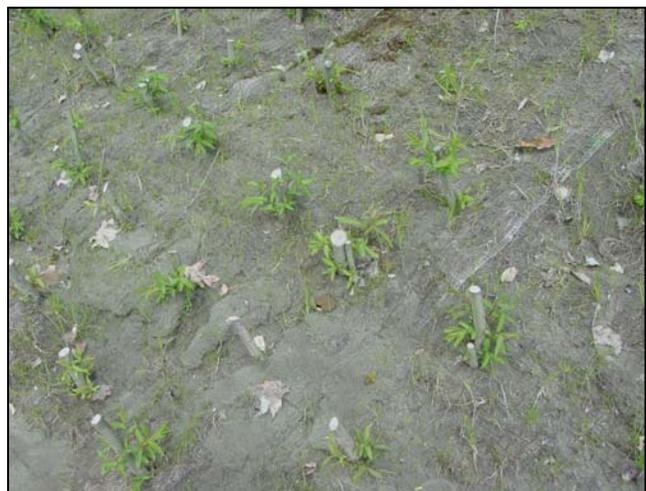
**Photo 9:**

Willow stakes beginning to sprout.
