OPERATION & MAINTENANCE PLAN
S.319-FUNDED BIOENGINEERING BANK STABILIZATION SITES
CONNECTICUT RIVER WATERSHED RESTORATION
PHASE I 96-08/319; PHASE II 00-04/319; PHASE III 03-07/319

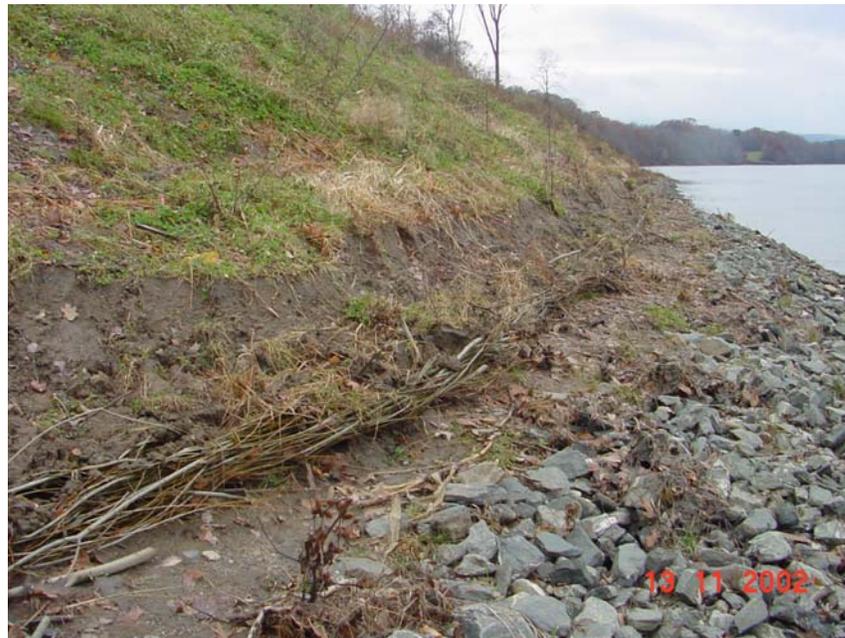
**Installation of Coir Fascines and Live Stakes at Urgiel Upstream Site
November 2002**

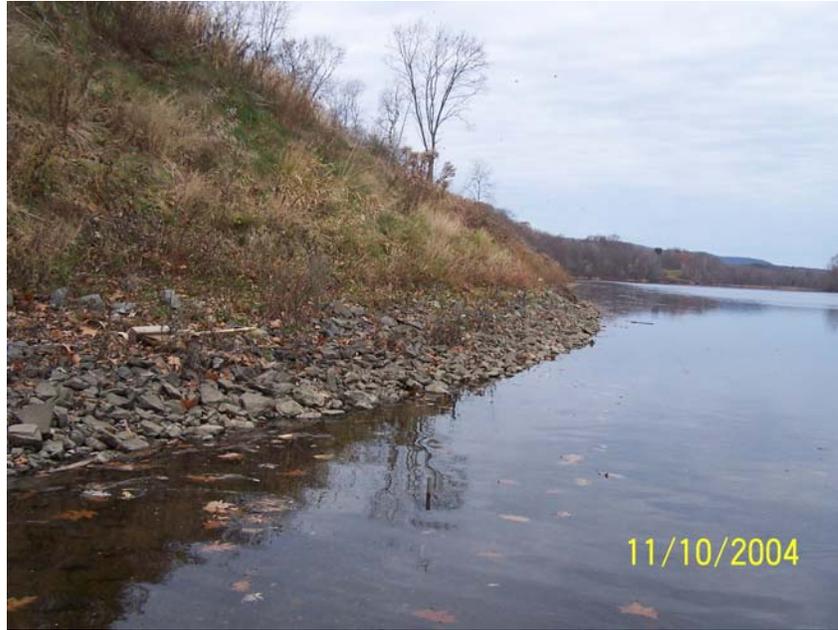
Urgiel Upstream Site Area of Repair - November 2004

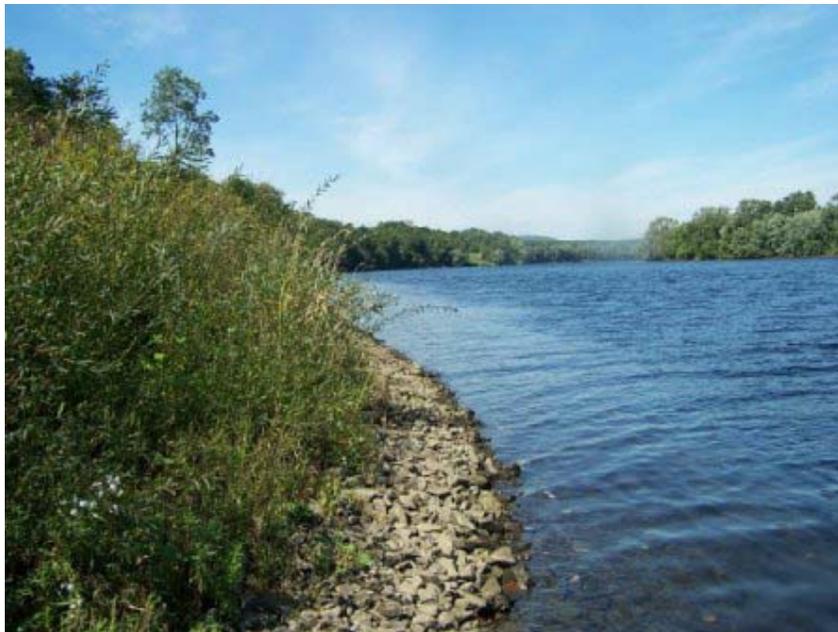
Urgiel Upstream Site Area of Repair - September 2005

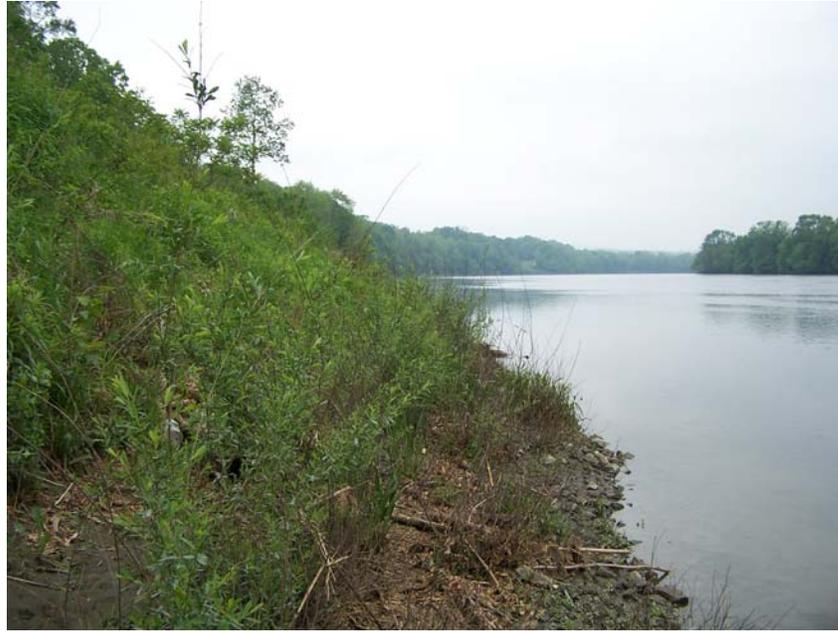
Urgiel Upstream Site Area of Repair – October 2006

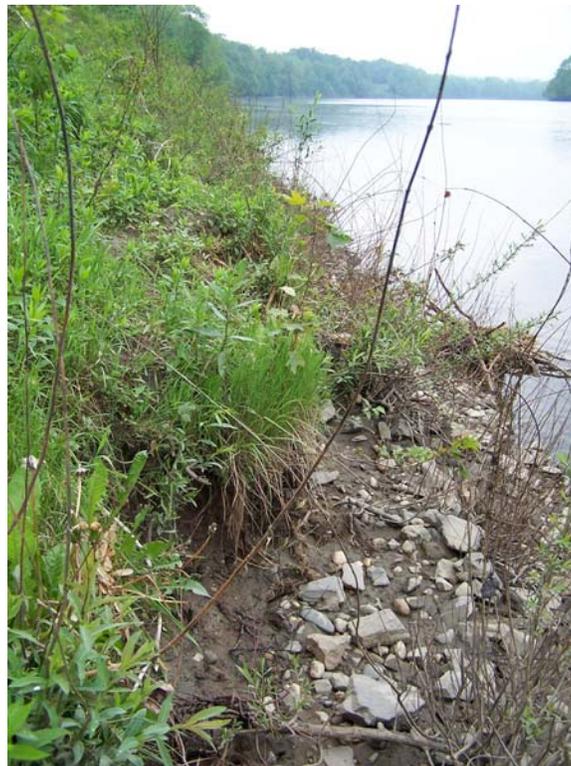
Localized Erosion between survey stakes 34 and 35. Looking upstream May 2006

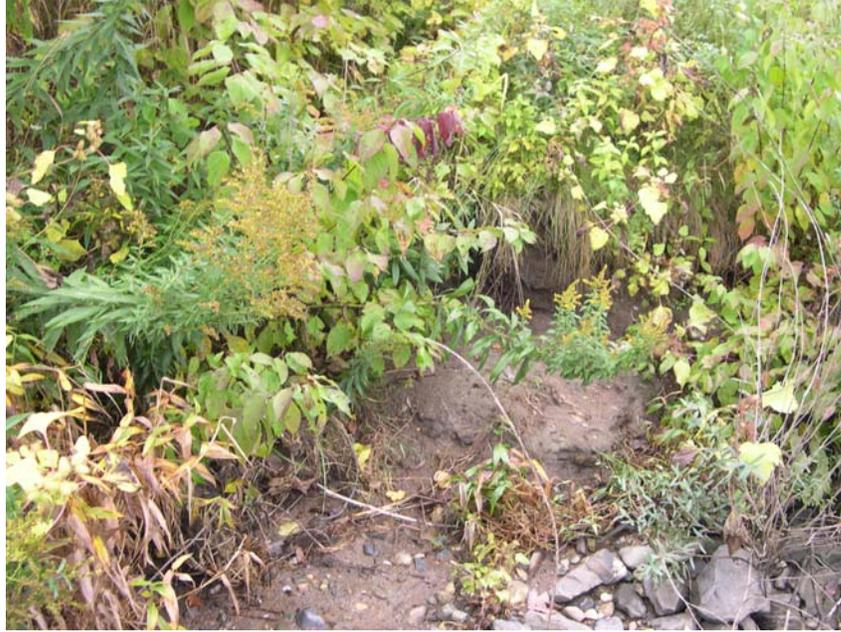
**Localized Erosion at Stone Toe/Lower Slope Interface at the Urgiel
Upstream site between survey stakes 34 and 35– October 2006**

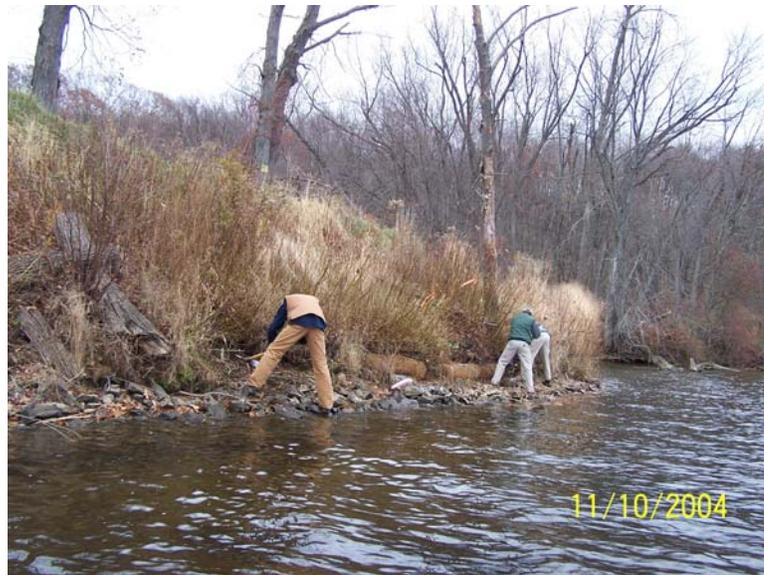
Repairs have also been made to the Shearer site to address erosion at the stone toe/lower slope interface.

Repair at Shearer Site – November 2004

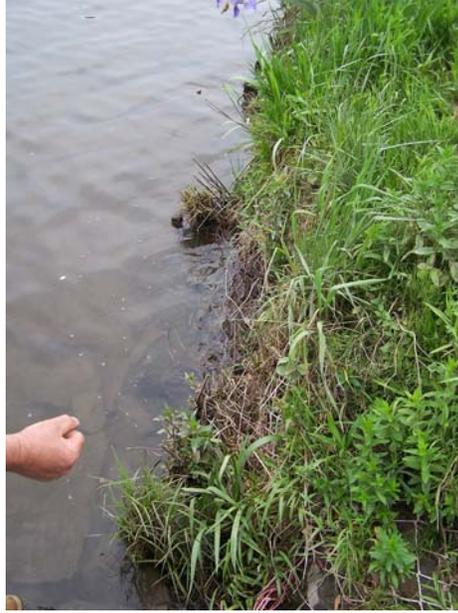
Portion of Repaired Area at Shearer Site – June 2006

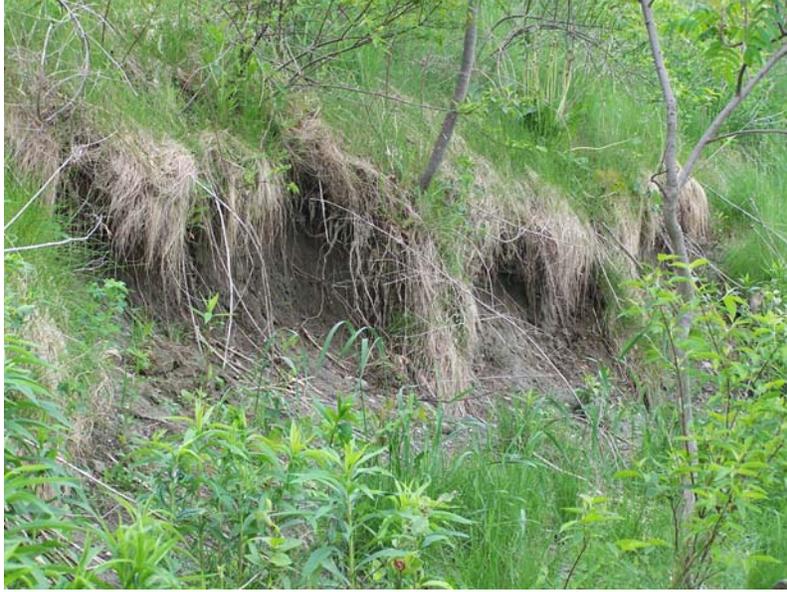
Areas of Bank Slumping: Localized areas of bank slumping have occurred at the Urgiel Upstream site. Slumping has not been a problem at the Phase I sites, which may be due to the different bank stabilization design used for the Phase I sites (geogrid lifts, brush mattresses, and brush fascines). The Phase I bank stabilization techniques were more “engineered” and contrast markedly with the designs for the Phase II and III sites, which, other than the bank regrading, called for much less intensive stabilization techniques (seeding and the installation of potted plants and trees). Small, localized slumps do not necessarily indicate impending, massive slope failure. However, these areas must be monitored to: 1) ensure that their size and severity does not increase; 2) ascertain if and how they “stabilize” and/or revegetate without intervention; and 3) determine if the areas become habitat for a particular species, which is what has happened at the Urgiel Upstream site.

Urgiel Upstream – Bank Slump/Erosion at Stake 35 – May 2006

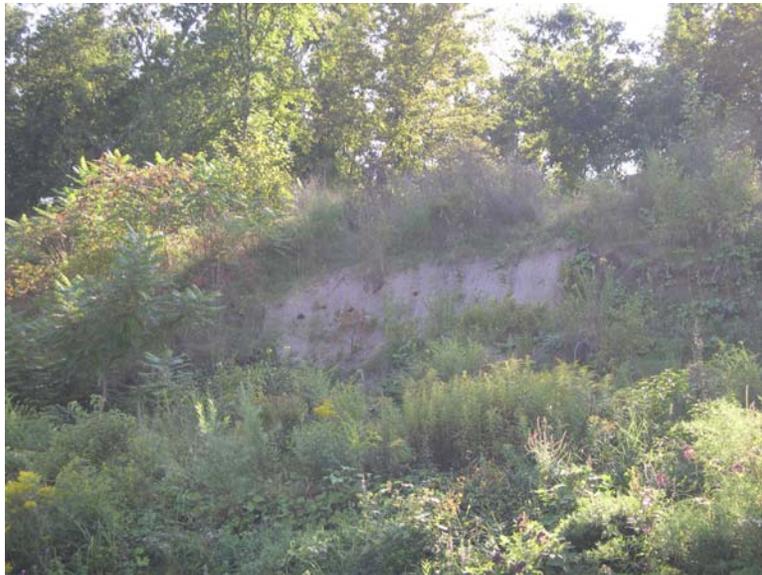
Urgiel Upstream – Eroded/Slumped Bank Face with Bank Swallow Nesting Cavities? – September 2006

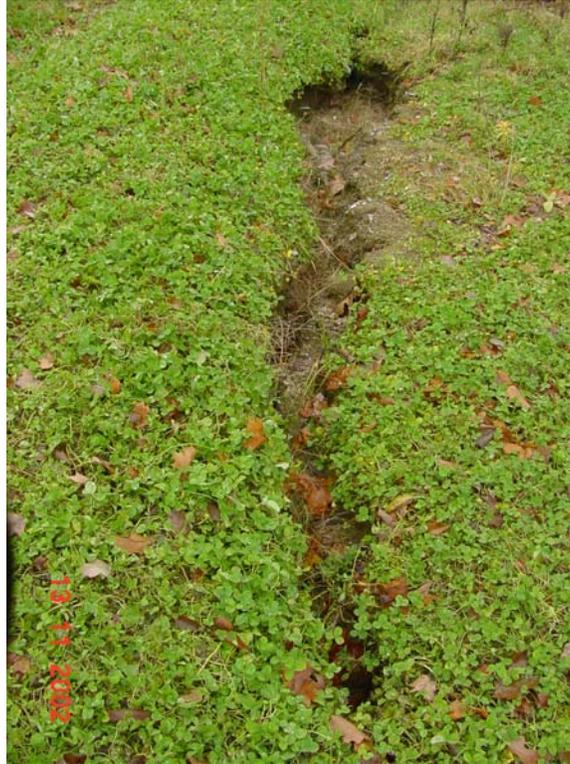
Areas of Erosion Caused by Overland Runoff: In November 2002, another area of the Urgiel Upstream site that needed repair was a downstream section of the top of the bank. High runoff volume/velocity and/or ponding behind the berm at the top of the bank created a gully in

the top of the bank. Apparently, surface water runoff was not being channeled to the rip-rap apron at the downstream edge of the site.

Crack in the Top of the Bank behind Berm – Urgiel Upstream Site November 2002

The area was repaired by placing gravel in the bottom of the gully and then filling with soil to bring it back up to the existing grade. The downstream end of the berm was extended to wrap around the edge of the site to channel runoff back into the undisturbed, wooded portion of the site.

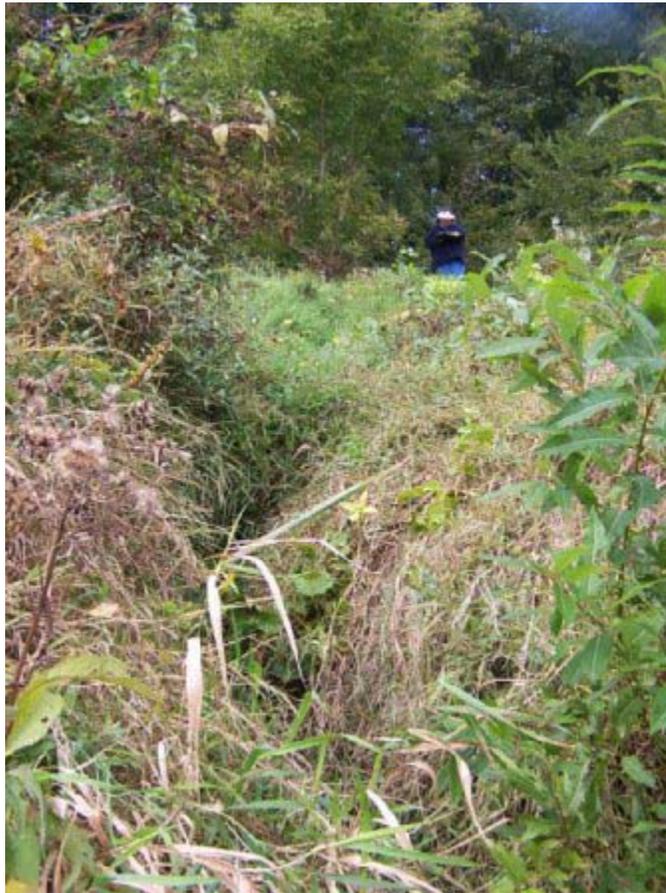
Wickey Site – Gully caused by overland runoff – June 2006
