NEW ENGLAND ENVIRONMENTAL, INC.

Sediment & Erosion Control Monitoring

Project Name:	Phase III Bank Restoration - Connecticut River	Submitted To:	DEP, Western Region		
Inspection Date:	10/23/09	Address:	436 Dwight Street		
Inspection Time:	Though out day	Town:	Springfield	State:	MA
NEE Project #:	08-3247	Zip:	01103		
MA DEP Permit #:	162-0068	Next Inspection Date:	10/30/09		
Observers:	Ryan Joyce	Client:	First Light Power Resources LLC		
Report # - Storm Event #:	Report - 2- Week 1 of Construction	Photos Included:	YES

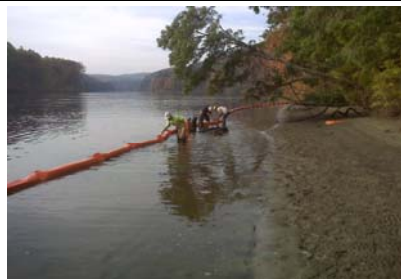
Davenport crews installing the turbidity curtain.

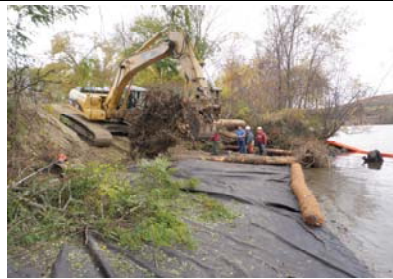
View of the start of construction on the root wads structures and bench.

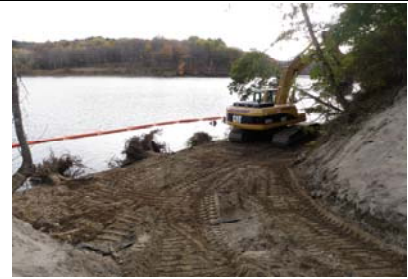
View from access ramp of construction of the root wad structures and bench.

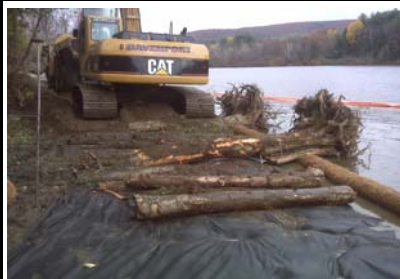
View of the root wads and log during construction of the aquatic bench.

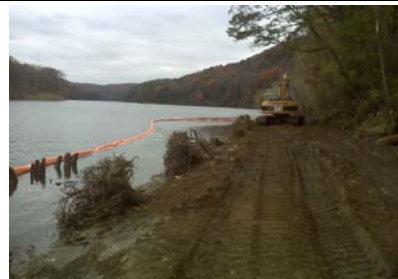
View looking down river at the aquatic bench

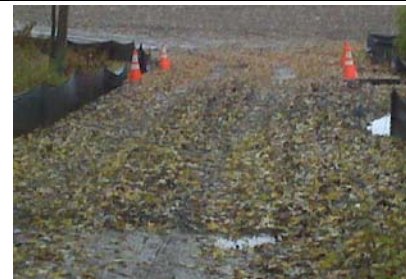
Construction Entrance:	The construction entrance is in good condition. The entrance will be monitored for sediment accumulation and removed as necessary.
Temporary Stockpile locations	The two temporary soil stock piles are contained and in stable condition. One pile is in active use during construction. The second pile contains the material excavated from the construction access ramp. This pile is completely contained and covered. This material will not be used until the end of the project when the ramp location is restored to existing conditions.
Erosion Control Barrier:	A complete inspection of the barrier is conducted daily to ensure proper functionality. The barrier is in good condition. Staked, straw bales were placed at the top of the construction access ramp.
Action taken on previous recommendations:	Continue to monitor the erosion control barriers, construction entrance and stock pile areas. Address areas as necessary.

View of the construction entrance to site.

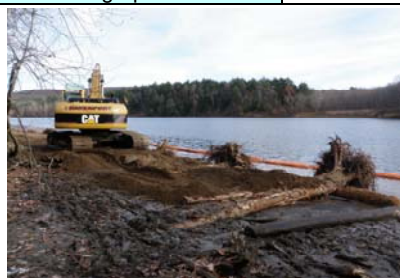
View of the bench construction and large woody debris .

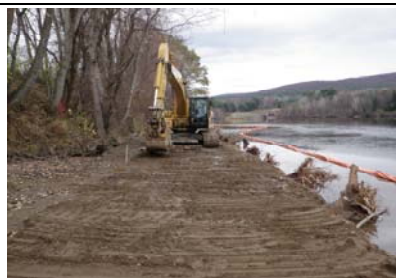
View the operator "dressing out" or stabilizing the bench. This is performed each night before the crews leave the site.

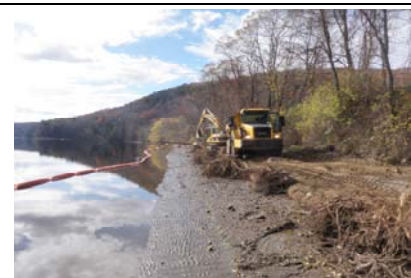
View of the bench and river looking south.

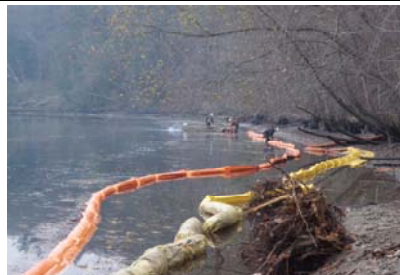
Turbidity Curtain:	The 8' curtain was installed from station 16+00 through station 10+00 (end of the aquatic bench). The curtain is inspected daily before the start of construction. Periodic adjustments were made to the curtain during the week.
Construction Entrance:	The construction entrance is in good condition. The entrance will be monitored for sediment accumulation and removed as necessary.
Temporary Stockpile locations	The two temporary soil stock piles are contained and in stable condition. One pile is in active use during construction. The second pile contains the material excavated from the construction access ramp. This pile is completely contained and covered. This material will not be used until the end of the project when the ramp location is restored to existing conditions.
Erosion Control Barrier:	A complete inspection of the barrier is conducted daily to ensure proper functionality. The barrier is in good condition. Staked, straw bales were placed at the top of the construction access ramp at the end of the work day.

View of the installation of the 8' turbidity curtain.

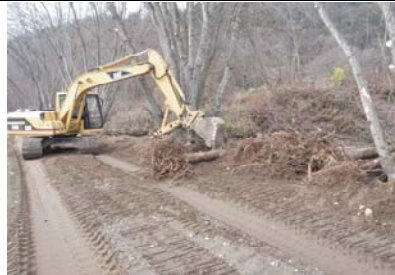
View of LWD placement within the scalloped eroded areas.

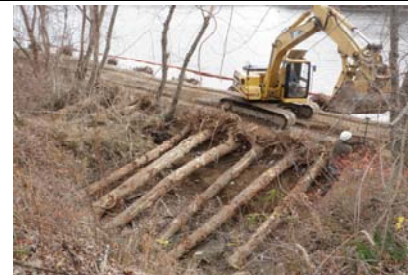
View of LWD within the scalloped eroded areas.

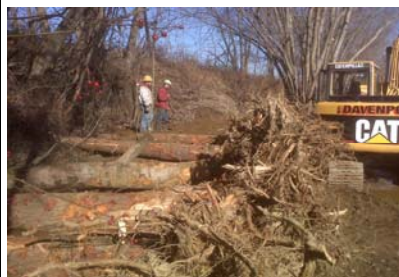
View of the construction of the "scalloped" eroded areas.

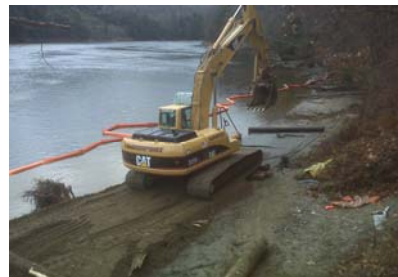
View of the construction of the last 100 feet of the aquatic bench.

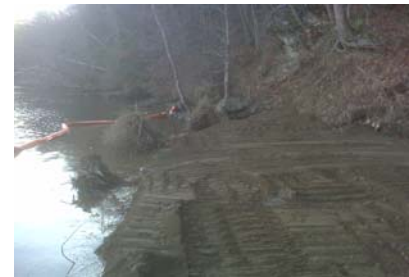
View of end of the aquatic bench.

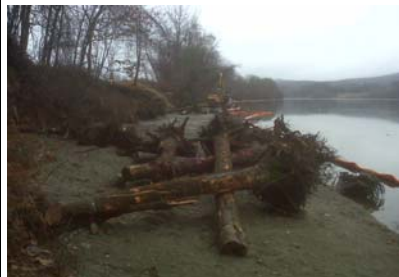
View looking north at the first LWD structure.

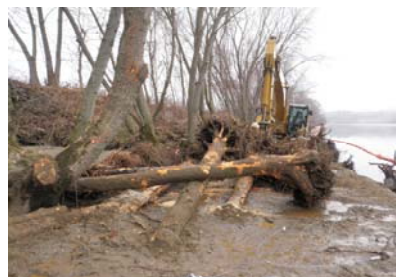
View of the construction of an LWD structure.

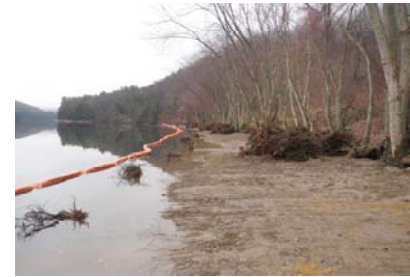
View looking south of the LWD structures and the bench.

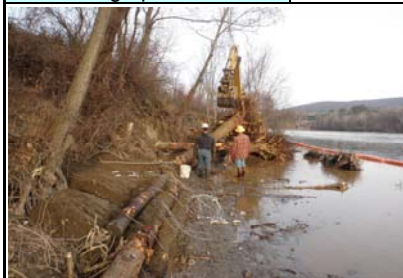
View looking north at the last LWD structure.

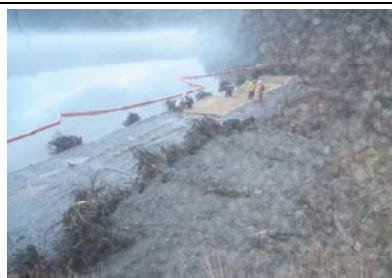
View of the erosion control fabric installation

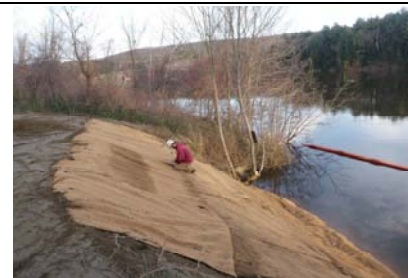
View of the start of the restoration treatment to the access road.

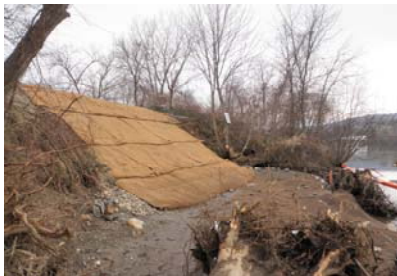
View of the restoration treatment to the access road

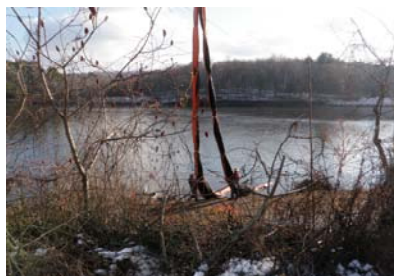
View of the turbidity curtain removal.

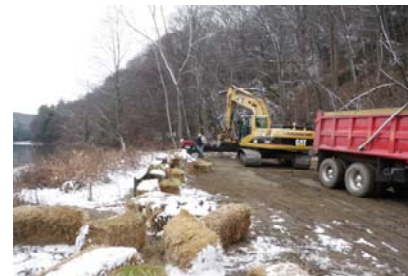
Removal of one of soil stockpiles.
