**FINAL CONSTRUCTION REPORT – Country Road Site  
FERC PROJECT # 1889/2485  
TURNERS FALLS/NORTHFIELD MOUNTAIN PROJECTS  
BIOENGINEERING BANK AND SLOPE STABILIZATION  
CONNECTICUT RIVER, MASSACHUSETTS**

**November 6, 2006**

**FINAL CONSTRUCTION REPORT – Country Road Site**  
**FERC PROJECT # 1889/2485**  
**TURNERS FALLS/NORTHFIELD MOUNTAIN PROJECTS**  
**BIOENGINEERING BANK AND SLOPE STABILIZATION**  
**CONNECTICUT RIVER, MASSACHUSETTS**  
**Site Report**

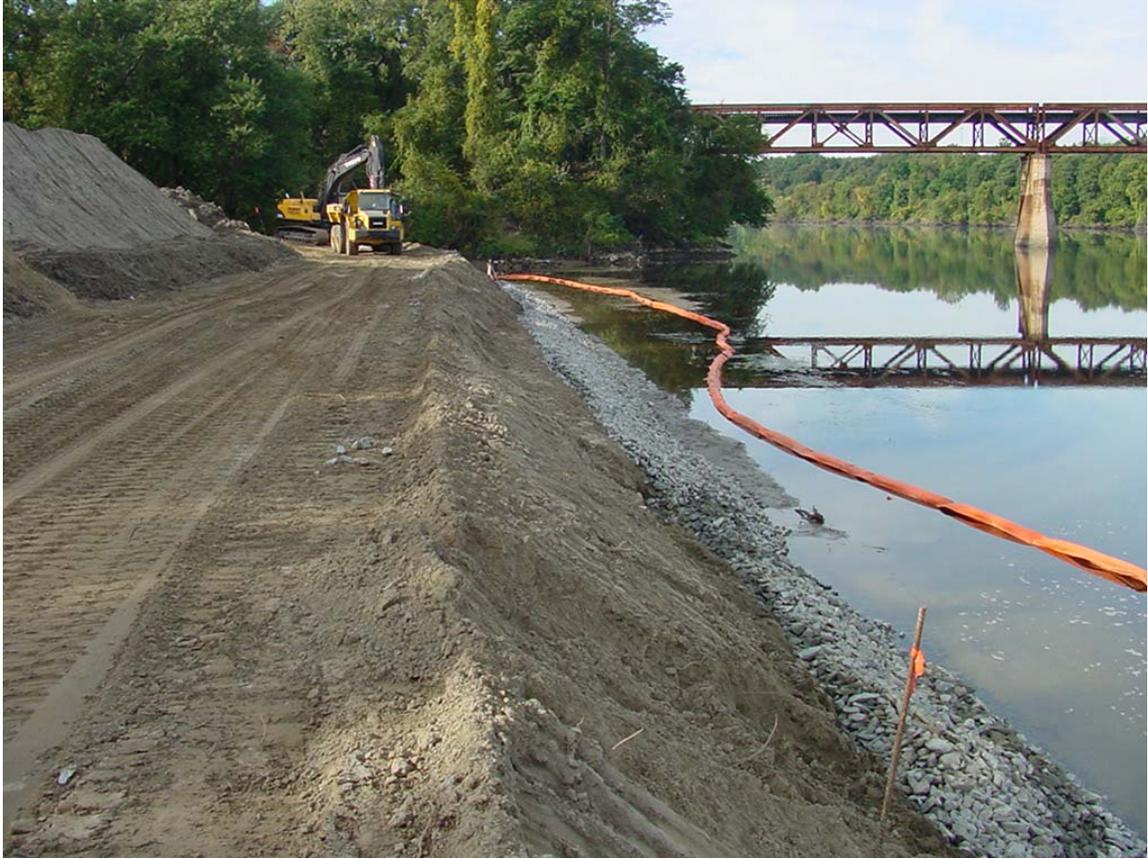
Creating the stone toe

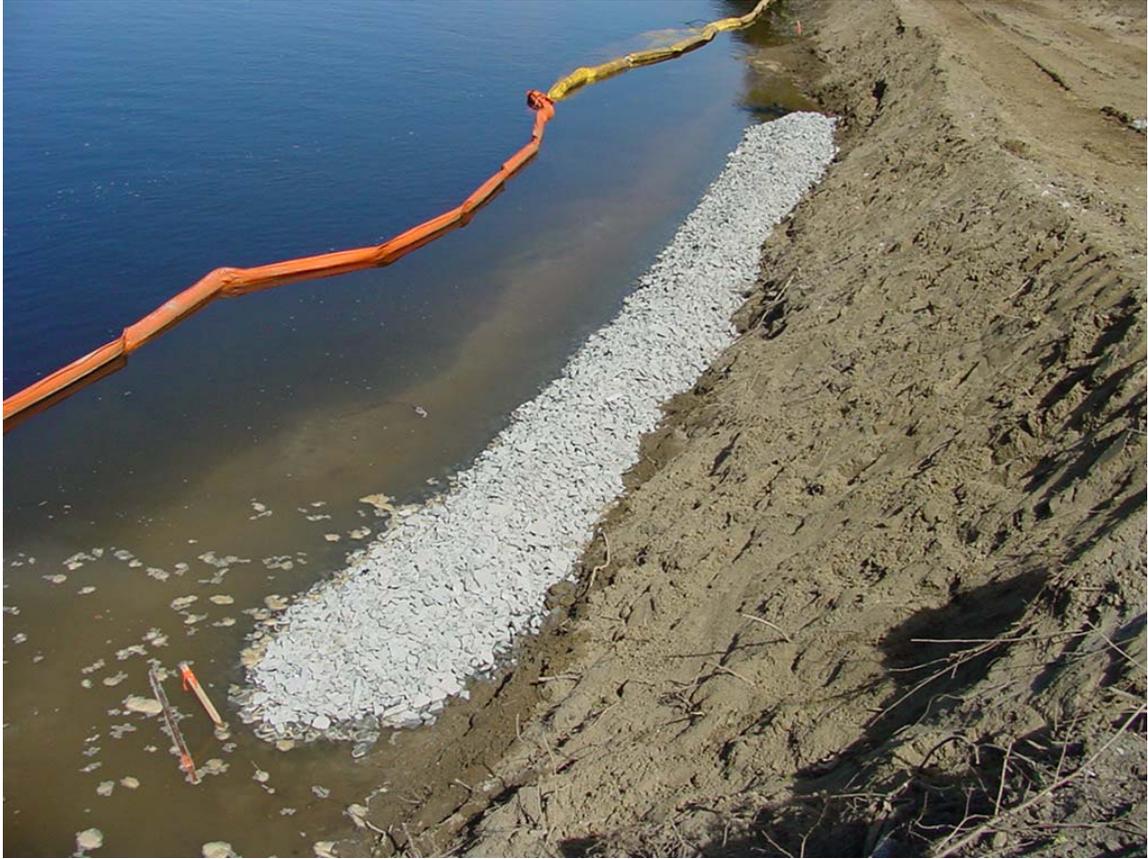
Stone toe with emergent aquatic shelf to the left of the stone toe

A triangular stacked 3 coir log break water arrangement secured with duckbill earth anchors and stainless steel aircraft cable creates an emergent shelf where aquatic native plants are planted. The shelf abuts the stone toe of slope composed of 2"-4" diameter stone is placed at the water's edge at an elevation within the normal elevation range of the pool. Based on experiences with the Phase I projects, the stone specified was downsized from 4"-6" inches in prior projects as there has been no movement or shifting of the stone due to near bank shear stress. The stone toe was Dutch wrapped in filter fabric. This minimizes sediment leaching through the stone as well as reduces the tendency of the stone settle far into the river bottom silt. The toe of the bank slope above the rock rip-rap is stabilized with a Pyramat. The Pyramat, which are secured to the bank with 6 inch staples and willow stakes, creates a two horizontal to one vertical (2H to 1V) slope with the fill backing.

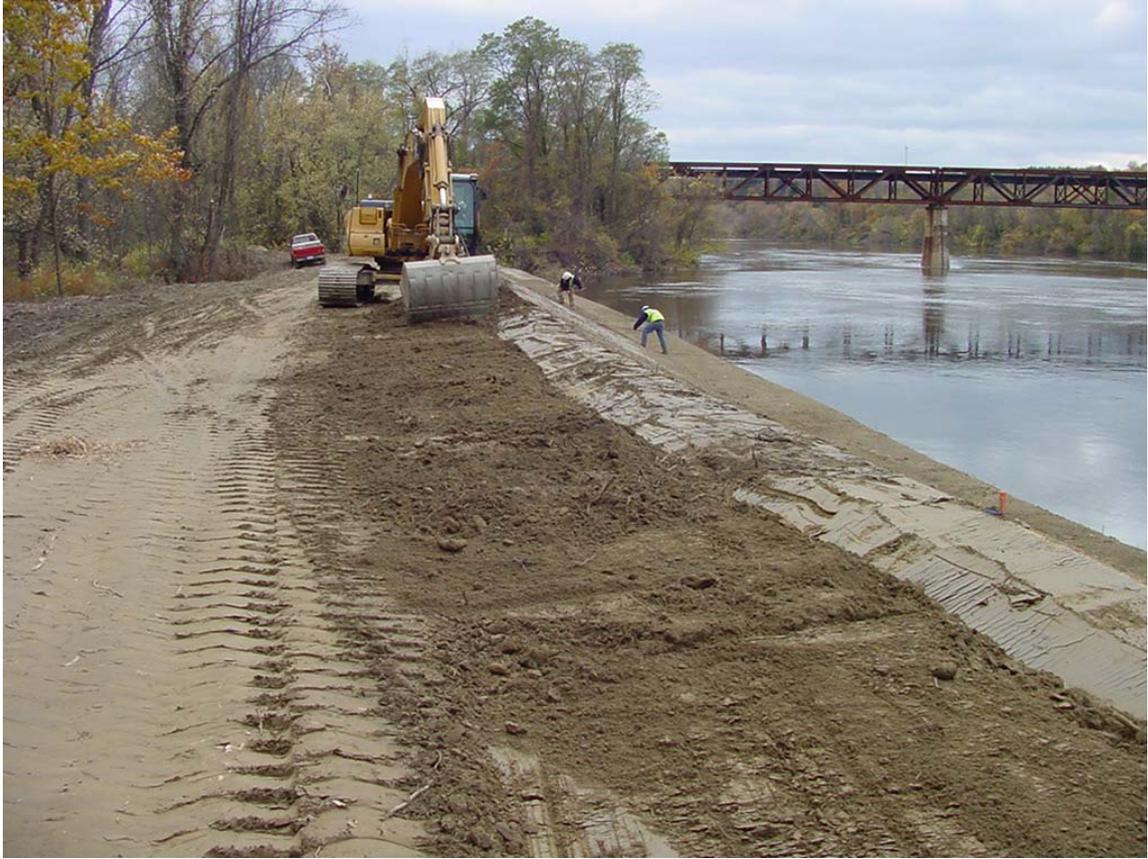
Final grading

The upper bank region of the project in areas above the breakwater and hard toe treatment has been re-graded to a slope of at least (2 H to 1 V) and in some areas (2.5 H to 1 V). A concerted effort was made to develop a grade more suitable than the angle of repose for the native un-consolidated material. A minimum of 6 inches of quality loam was graded onto the banks and the entire area was seeded with a native seed mix. Erosion control material (biodegradable erosion control blanket of 700GSM Coir matting) was placed over the entire graded bank.

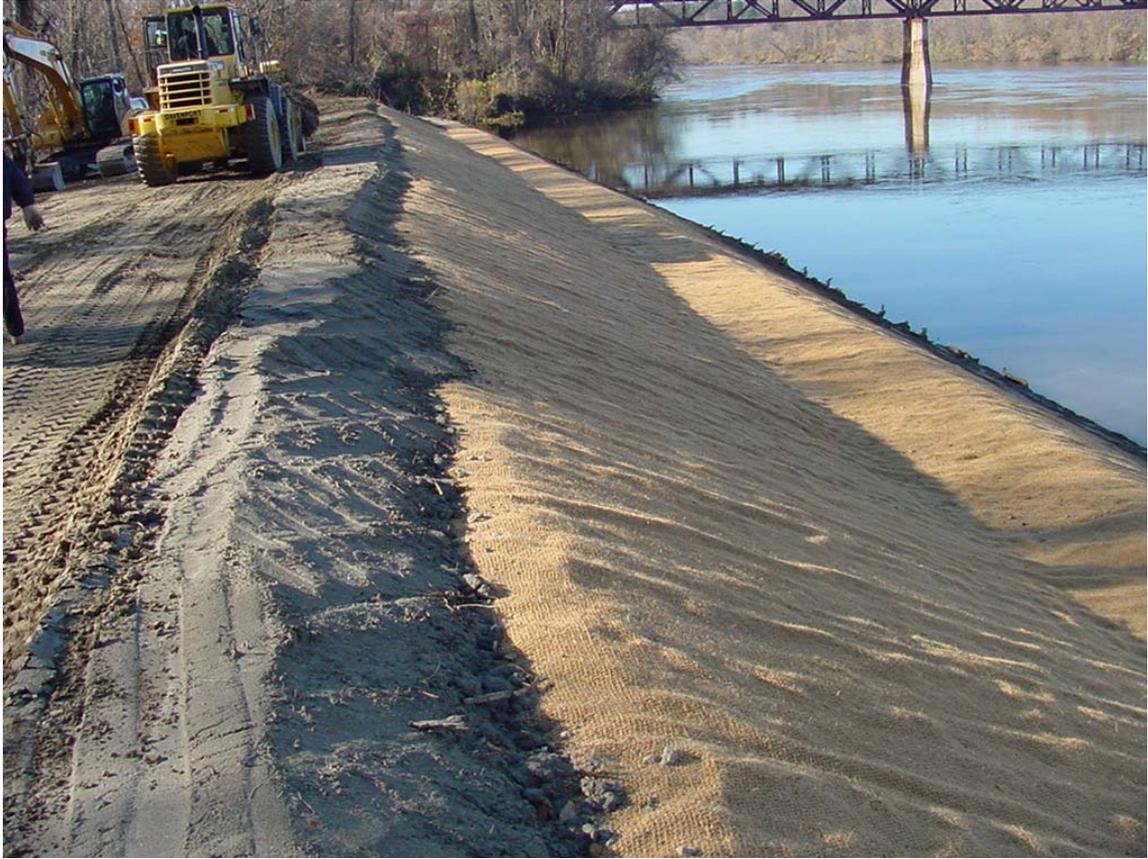
Final grade with coir matting installed
